DEAN-KEENER-CRIM HOUSE*

**Master Plan for the
Historic Dean-Keener-Crim House
Kilgore, Texas**

**Kilgore Historical Preservation Foundation
Kilgore, Texas**

Evaluation of Existing Conditions

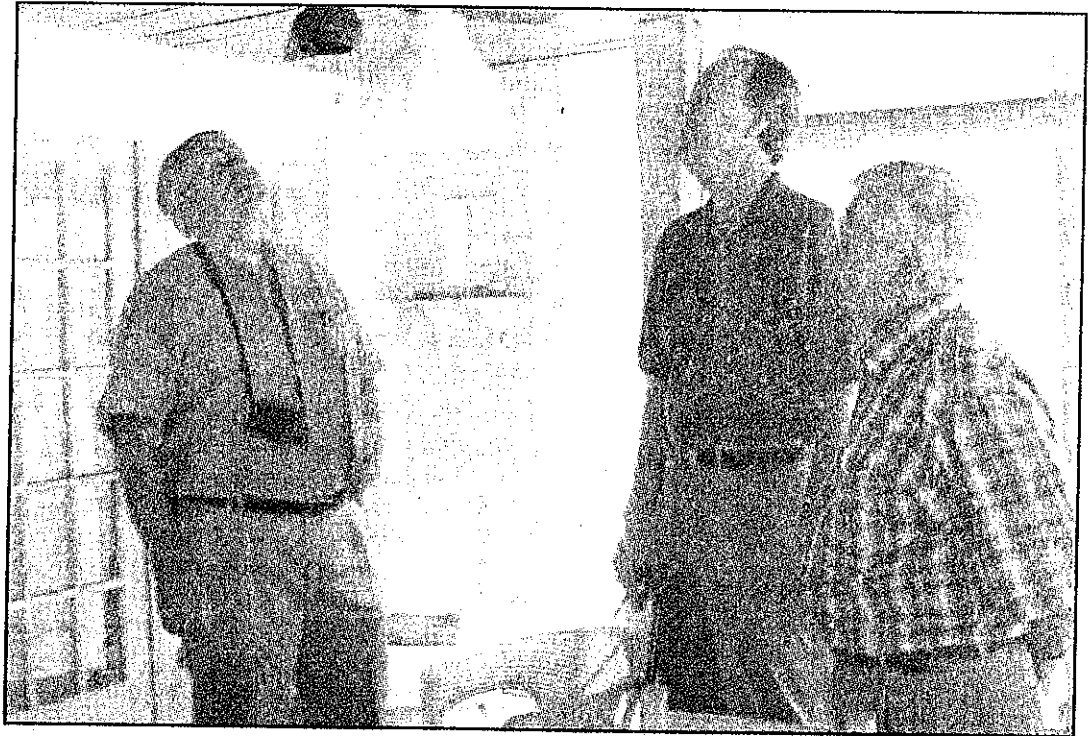
Photo by December Cole

Tom Paxson, left, president of the Pax-Sun engineering firm, Gerald Bratz, a restoration and preservation architect, and Gene Tiogo, structural engineer, look at wiring problems in the back porch of the Dean-Keener-Crim house.

All electrical wiring in conduit will be inspected and replaced as required. "Romex" cables will be removed and replaced with THHN conductors in conduit. Existing receptacles and light fixtures will be inspected and reused if serviceable. Existing serviceable light fixtures will be removed, refurbished and replaced. Emergency and exit lights will be added as required by code. The outbuildings will be rewired (Phase II) and additional site lighting will be installed.

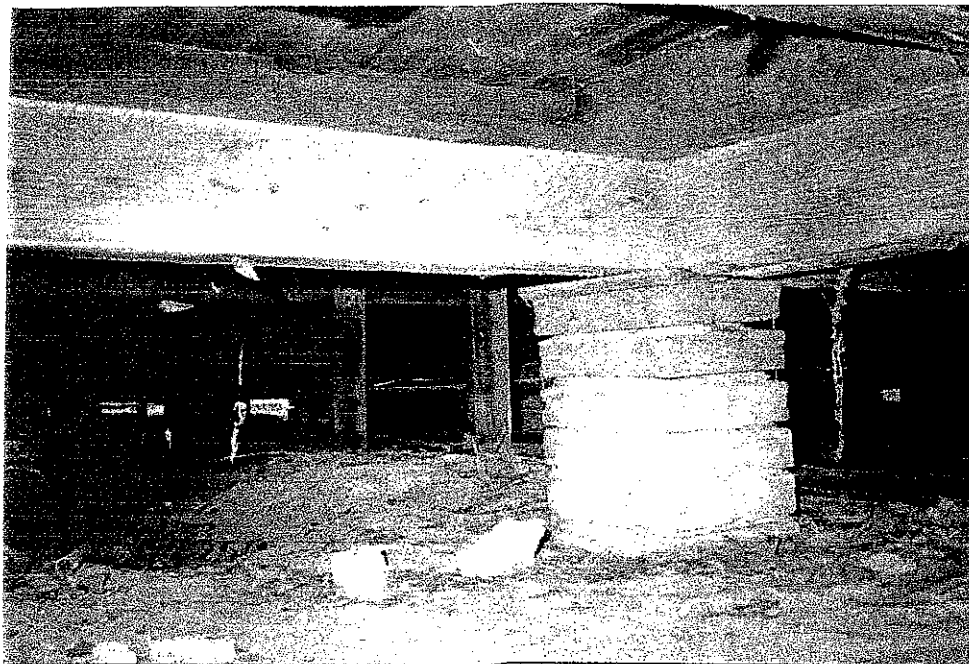
After the death of the last Crim family member in 1999, the historic house stood unattended for a number of months. During this period there was an undetected plumbing leak which undermined soil bearing material at the masonry piers. Consequently the foundation support has shifted, particularly in the area of the c. 1902 "bathroom tower."

9 House - Masonry Foundation at Porch 3

While at the time of my examination, the residence is structurally sound, there are many deficiencies that if left as is, may lead to more severe damage to the house. The house requires leveling. The leveling may require the replacement of warped wood floors in several areas. The internal condition of the fireplaces is unknown. Open flame gas heaters have been installed in both fireplaces to replace the burning of firewood. The fireplace in the master bedroom requires repairing to have it properly installed and finished. No structural damage to the stair to the second floor was observed. I believe it to be in sound condition and that it will require minimal re-work. The existing tin skirt should be removed and replaced with a skirt that will provide sufficient ventilation of the crawl space to keep the space dry and free from odors caused by standing water. Consideration should be given to raising the house to provide adequate space below the house to service and repair plumbing, piers and wood beams.

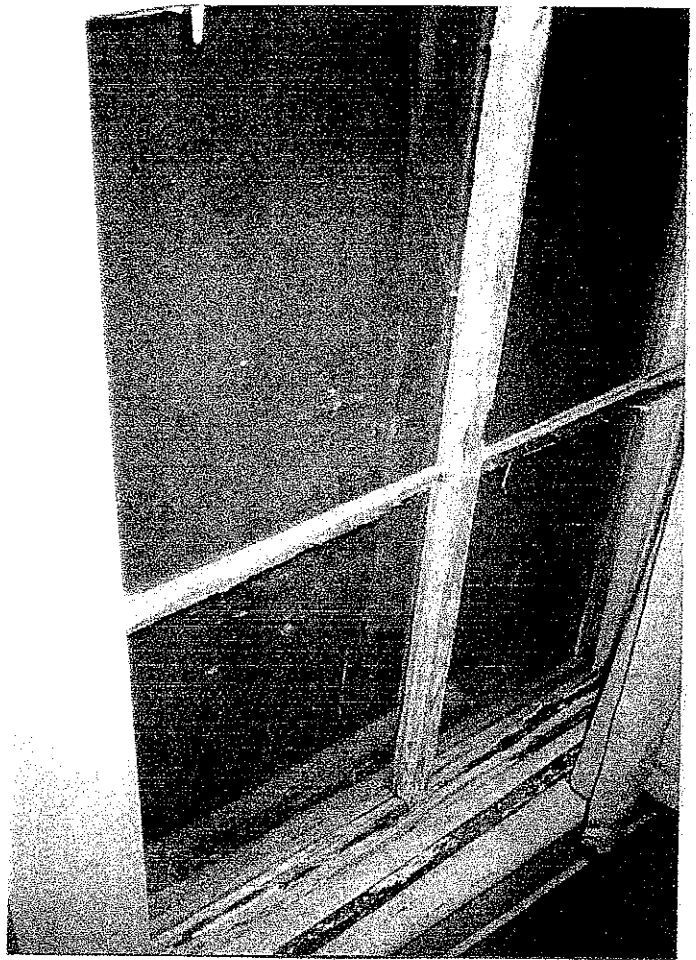
26 House - Second Floor Interior Elevation
Bedroom 4 - Damaged Window

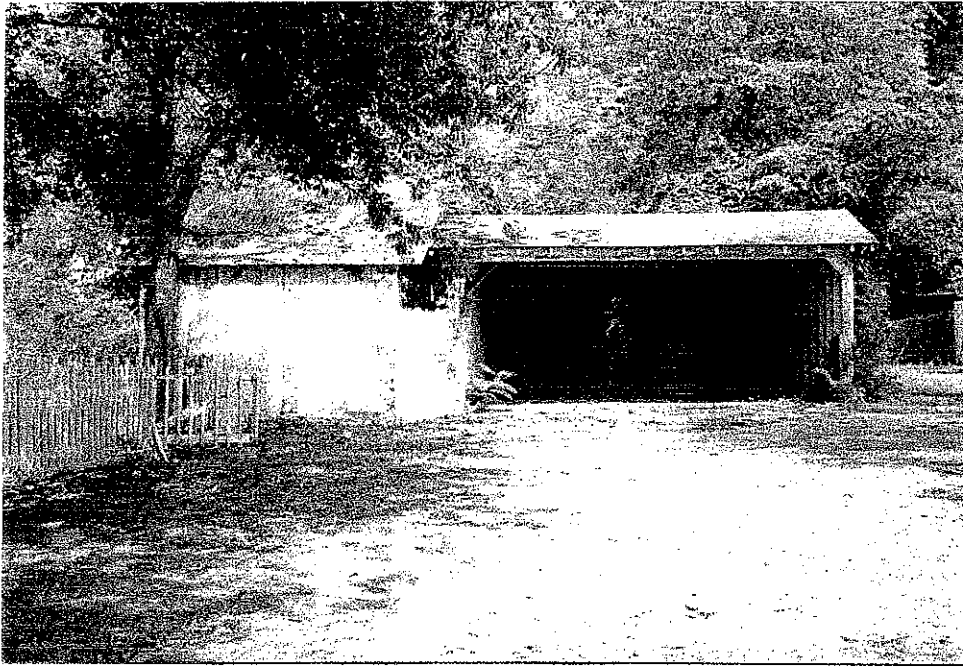
The spacing of the brick piers in the garage is too great to prevent the walls from sagging. Continuous support of the floor sills is required to eliminate the wall sag. The undersized double 2 x 6 wood beams supporting the roof deck cause the beams to sag. The sag in the beams is permanent and will require the replacement of the 2x6's with heavier members. Bracing is required in the exterior walls to keep the walls from racking and to meet building code requirements. The earth floor should also be replaced with a concrete floor. It is my opinion that it would be more cost effective to replace the structure than to try to repair it.

29 Garage / Storage - South Exterior Elevation

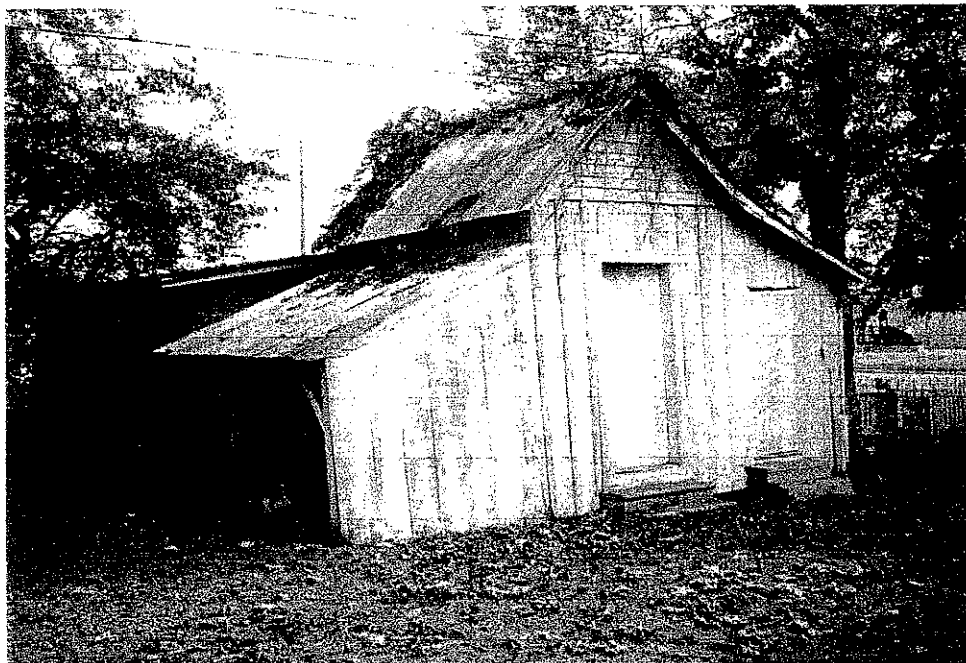
- Exterior paint coating on the siding is severely peeling,
- Several siding boards have rotting ends at ground level,
- Warped floor and rotting floor decks,
- Rotting posts at the shed, and a
- Rusting corrugated roof deck.

31 Shed / Smokehouse / Storage
Northwest Exterior Elevation View

The Smokehouse requires extensive repairs to the floor deck and exterior wood siding. If the covered shed at the north side of the building is to remain, the three wood posts supporting the roof should be replaced and supported on concrete piers. The bottoms of the

posts should be isolated from the concrete and soils. The roof framing requires the strengthening and replacement of several members. The wood flooring in the storage room south of the smoke room also needs repair and replacement of rotted boards.
