DEAN-KEENER-CRIM HOUSE*

**Master Plan for the
Historic Dean-Keener-Crim House
Kilgore, Texas**

**Kilgore Historical Preservation Foundation
Kilgore, Texas**

Evaluation of Existing Conditions

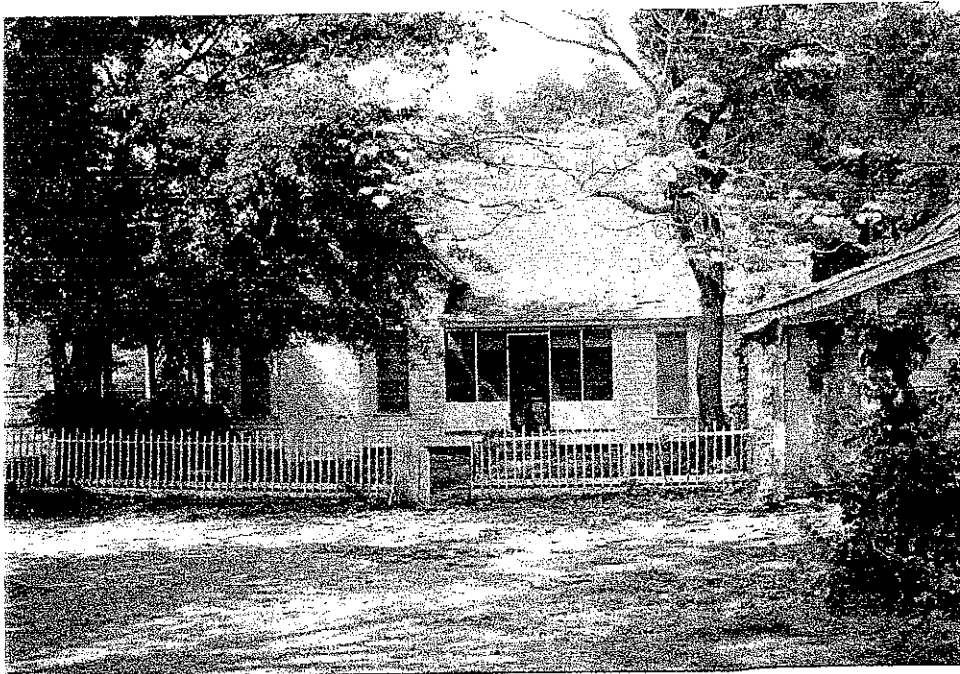
6 House - East Exterior Elevation

- Floor decking on the rear porch has several rotting boards,
- Damaged brick piers supporting the floor beams, at the north east corner and along the east side,
